# FENDER KATSALIDIS ARCHITECTS

2 Riverside Quay, Southbank

**RE:** Proposed Alterations and Additions at:

**No. 99 Hotham Street, East Melbourne.**

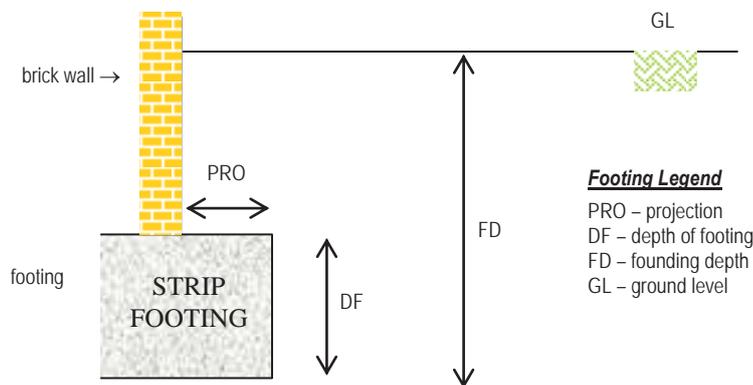
The existing adjacent footing were exposed at borehole 3 (see figure 1), dimensions and founding material are shown below, depths are relative to the existing surface levels at the time of the investigation.

<b>Location:</b>	Borehole 3
	East boundary
<b>Type:</b>	Concrete strip
<b>Founding Depth:</b>	1000mm
<b>Depth of footing:</b>	400mm
<b>Projection:</b>	100mm
<b>Founding material:</b>	silty CLAY

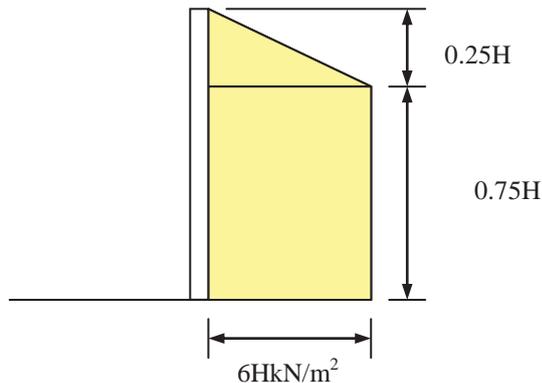
**Diagram 1 : Trapezoidal lateral earth pressure distribution**

Underpinning will be required to be designed to be retaining as per the lateral earth pressure distribution below. The underpins should be designed for a trapezoidal lateral earth pressure distribution using  $P_0 = 6H$  kN/m<sup>2</sup> where H equals the height of the wall in metres. The underpins should therefore be propped or tied back to ensure temporary support, or designed as gravity retaining walls. An adequate factor of safety should be applied. The lateral earth pressure distribution is summarized below:

Drainage must be provided behind the underpins or hydrostatic pressure added to the lateral earth pressure, ie strip drains nailed to the excavated face and allowed to drain to weep holes.

Any surcharges to the pins should be added to the lateral pressure adopting a  $K_s = 0.4$ .

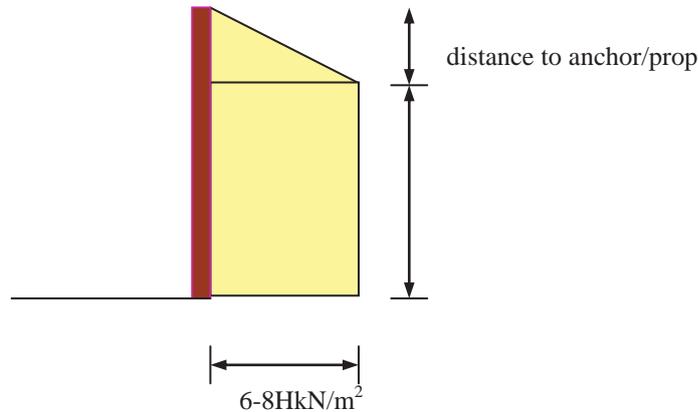
**Lateral earth pressure distribution for tie back walls\*:**

**\* Where tie-back, cantilevered or contiguous piles are used to support adjacent footings, lateral earth pressures should be increased to 8H kPa.**

Any additional surcharges should be added to the lateral earth pressure, i.e. hydrostatic, the line load from the existing building and surcharge loads. Note that AS4678-2002 recommends a minimum 5kPa surcharge loading to all walls.

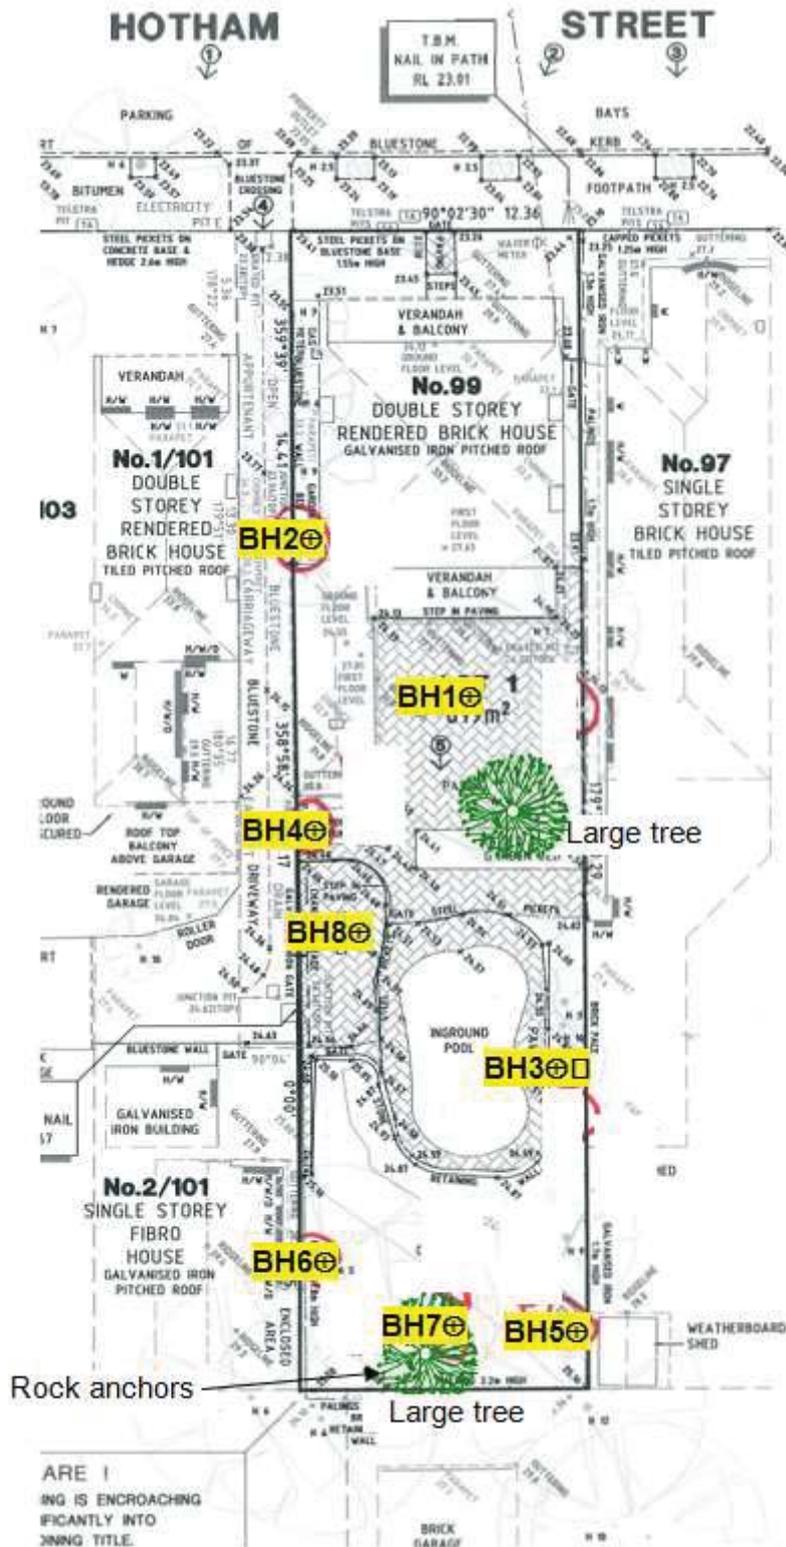
**Figure No. 1**

**LOCATION PLAN**

**Project:**  
 No. 99 Hotham Street, East Melbourne  
**Scale:**  
 Not to Scale (sketch for borehole locations).

**Legend:**  
 ⊕ Borehole  
 □ Footing inspection

**Borehole No.** 2      **Drilling method:** HA      **Location:** see figure 1.

**Borehole No.** 3      **Drilling method:** HA      **Location:** see figure 1.

**Borehole No.** 4      **Drilling method:** HA      **Location:** see figure 1.

**Borehole No.** 5      **Drilling method:** HA      **Location:** see figure 1.

**Borehole No.** 8      **Drilling method:** HA      **Location:** see figure 1.

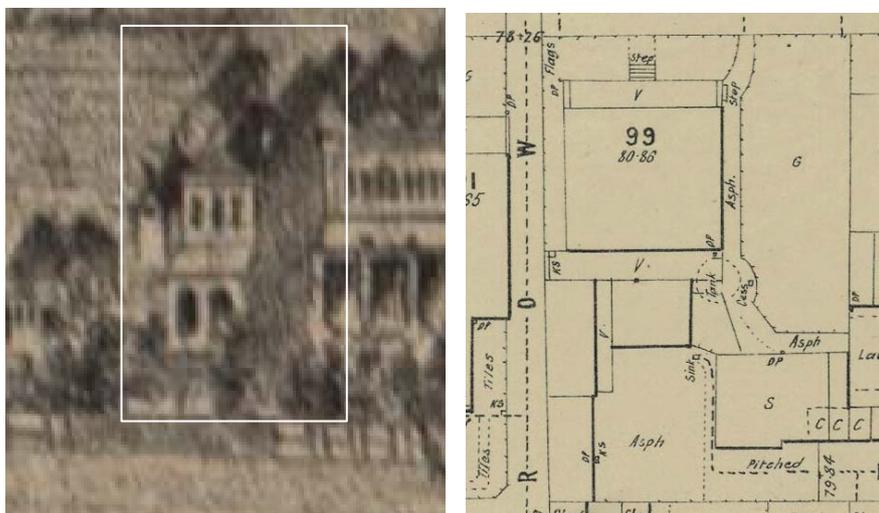
Figure 1 (left) Part of an 1866 isometric plan of Melbourne, possibly showing the building with a single storey verandah. Source: National Library of Australia.

Figure 2 (right) Part of an 1898 MMBW Detail Plan of East Melbourne showing the subject building. Source: State Library of Victoria.

An 1866 isometric map of Melbourne possibly shows the subject building with a single-storey arcaded verandah (refer figure 1 below). The rate book for 1866 describes an eight-room brick house on the site (then numbered 82 Hotham Street) with outbuildings and stabling. The occupant at this time was Robert Wigmore and the owner J Woolley (agent for the estate of George Robinson). The net annual value of the house remains constant at £90 through the 1860s, despite the number of rooms increasing to ten in 1869. The number of rooms remains at ten through to 1888 when the rate books describe a 13 room house with a net annual value of £150 (increasing £20 from the previous year). The change in value could result from a small addition or remodelling of the façade to create a double-storey verandah.

An 1898 MMBW plan shows the service wing in its present location but separated from the main house by a rear verandah (refer figure 2 below). Also visible on the MMBW plan is a small structure abutting the east side of the service wing – this might be an iron outbuilding described in the 1884 auction notice.

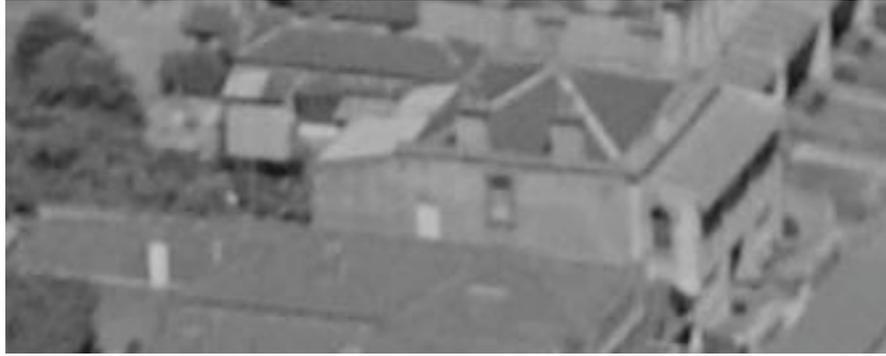
Figure 3 (right) A 1945 oblique aerial photograph showing the subject building with an enclosed double-storey front verandah and a verandah on the east side of the rear wing (since removed). Source: State Library of Victoria.

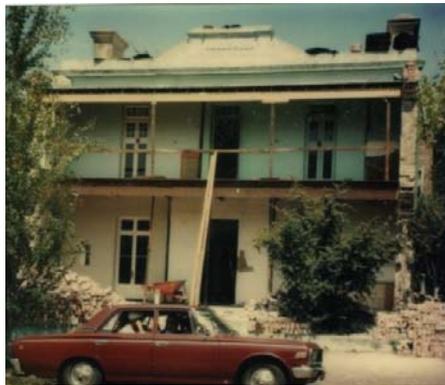
Figure 4 A 1977 photograph of 99 Hotham Street showing the present verandah under construction and the French windows already in place. Source: East Melbourne Historical Society.

By the early twentieth century, the subject building had been converted into flats and the front verandah enclosed. It was restored in 1977 when the present double-storey cast iron was introduced (refer figure below 4 below). Other changes to the exterior include the overpainting of face brick side and rear walls and recladding of the roof in corrugated steel. A 1945 aerial photograph (figure 3 below) indicates that the roof was originally clad in slate. The cast iron palisade fence is a recently built replica. The French doors on both levels of the front façade appear to be non-original (presumably replacing double-hung sash window frames – this must certainly be the case for the first floor at least, given there was originally no balcony at this level).

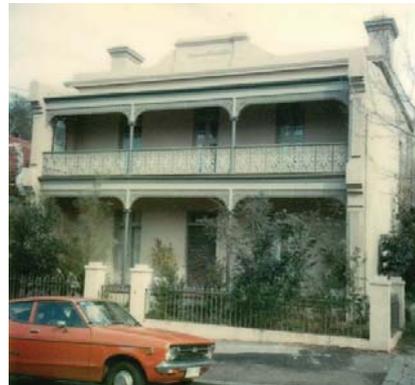
Figure 5 The house after completion of the restoration work, 1978. Source: East Melbourne Historical Society.

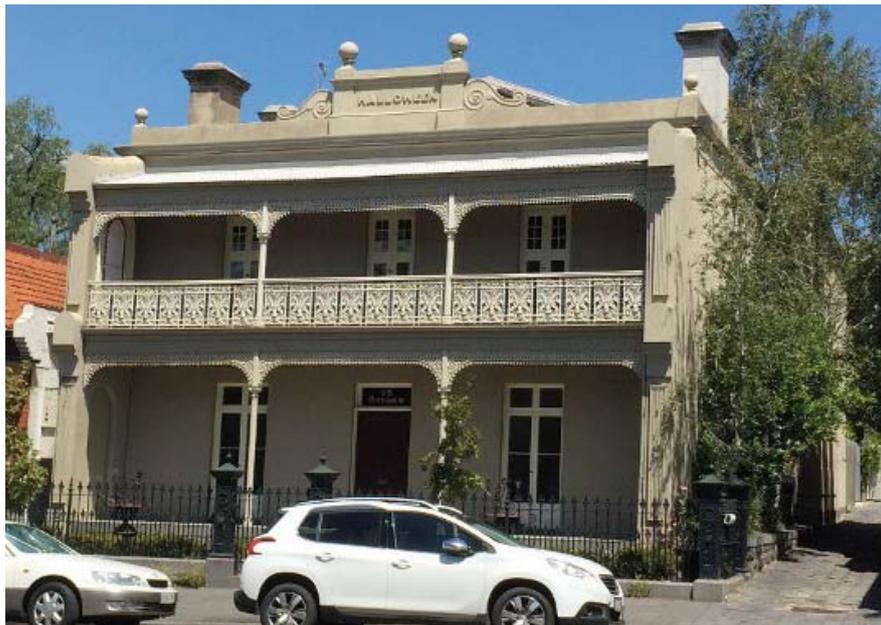
Figure 6 Current photograph of 99 Hotham Street. Note that the parapet scrolls and orb finials have been reinstated since the 1977 restoration.

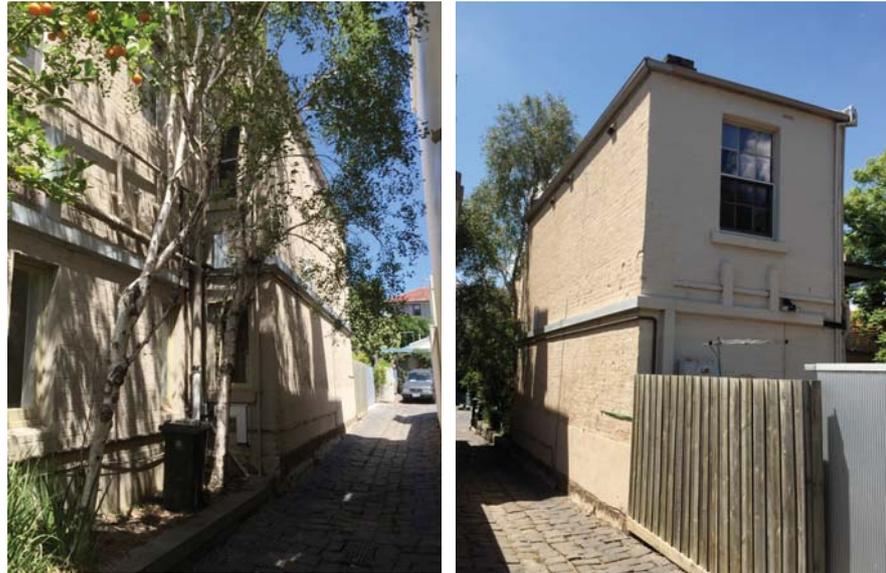
Figure 7 (left) The service wing viewed from the laneway entrance.

Figure 8 (right) The rear and side elevation of the service wing.
